Home Survey Report Sample

Dave Grandstaff
Southeast Home Inspections
1225 Pisgah Church Rd
Aynor, SC 29511
843-358-2241

246 North Elm
Smolderville, SC 29567
214-123-45676

March 4, 2004

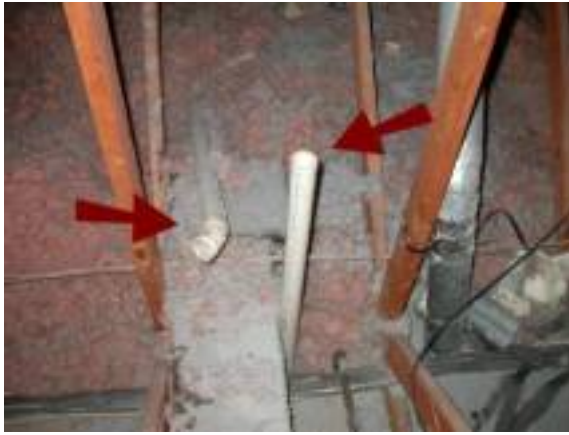
[4C.21](#) Broken plumbing vent pipe within attic.

ABS pipe, perhaps manufactured between 1985 and 1989—the following brand name was found that is subject of a lawsuit (pipes could fail): Centaur. This is an expense concern. Evaluation by a specialist is recommended

[4C.21](#) ABS pipe, perhaps manufactured between 1985 and 1989—the following brand name was found that is subject of a lawsuit (pipes could fail): Centaur.

This is an expense concern. Evaluation by a specialist is recommended
